The I-215; 4500 South Structure Project was sponsored by the Utah Department of Transportation (UDOT). HDR documented the information contained within this report and is solely responsible for its accuracy.

1.0 Project Background

The I-215; 4500 South Structure Project replaced Structure F-156 on SR-266 over I-215 and reduced impacts to the traveling public by using accelerated bridge construction (ABC). The new superstructure was constructed off-site. The new substructure was constructed under the existing bridge. Once the new structure was complete, the existing structure was removed and the new superstructure was moved into its final location. The structure was moved using a self-propelled modular transporter (SPMT) system. The innovative practice of Construction Management General Contractor (CMGC) contracting was also incorporated in this project.

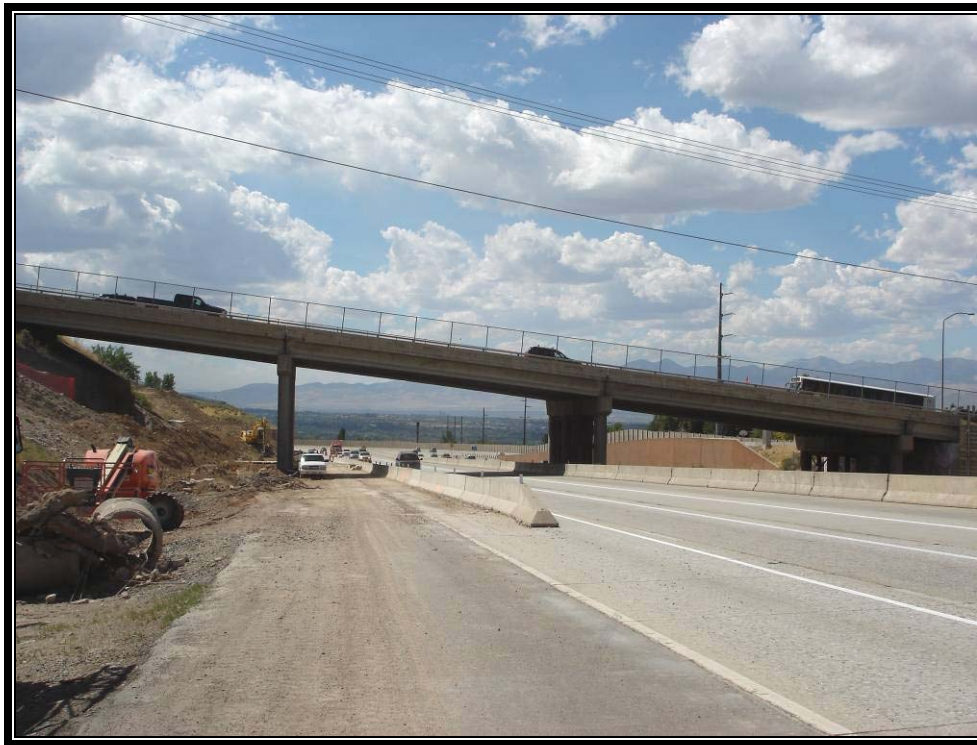
Figure 1. Existing Bridge Elevation

The existing 243.5-foot structure was built in 1971 and was a four span, prestressed concrete girder bridge. The existing bridge deck was approximately 76-feet 10-inches wide with sidewalks. The sufficiency rating for the existing structure was 40.

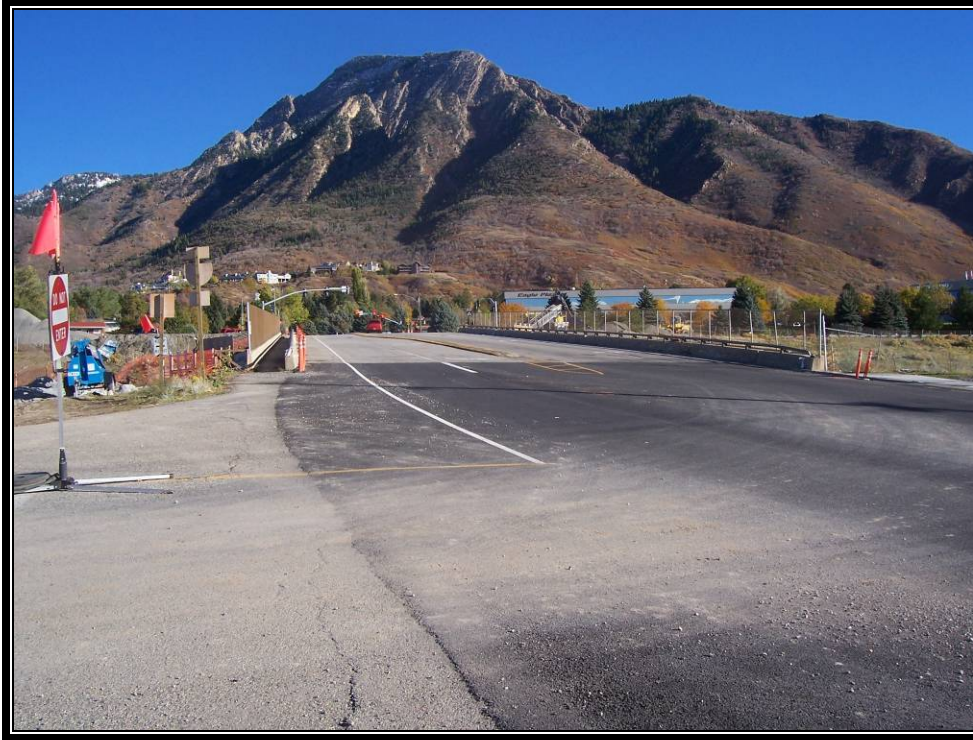
Figure 3. Geometric Layout

The geometry and layout for this bridge is extremely complicated. The I-215 northbound and southbound roadways have final grade elevations that differ by approximately 5 feet. The I-215 vertical profile is a 4% grade with a 2% cross slope. The 4500 South roadway is on a 12% grade with a varying cross slope. All of these factors created a very challenging project.

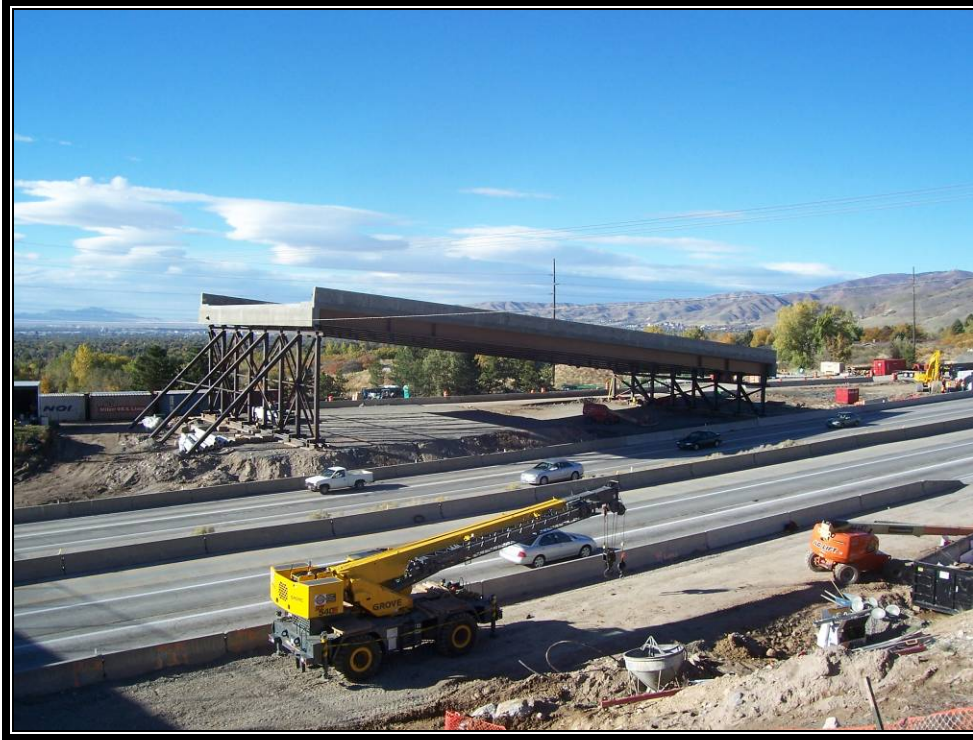
Figure 4. Superstructure Layout

The superstructure was built in its temporary location at a 9% grade to allow it to properly fit its final location at a 12% grade. As the bridge moved onto I-215, it rotated longitudinally upward at 3% to a final position of a 12% grade. All vertical components of the superstructure were tilted during construction to accommodate the movement from the temporary location to the final location. Jacks were used to tilt the superstructure transversely at 4% to accommodate the grades on I-215. With all the variables in geometry, the deck elevations were calculated for both the temporary and final bridge locations.

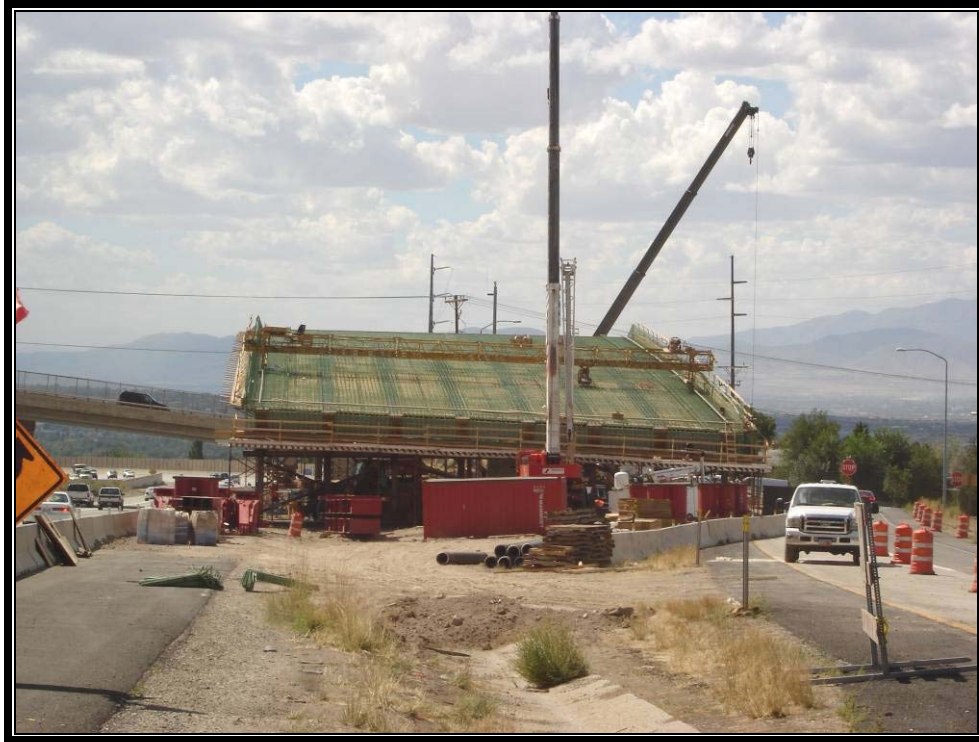
Figure 5. Superstructure

A single span structure replaced the existing four span structure. Shallow girders were required to meet vertical clearance requirements. Using a single span created a bridge with no joints, a simplified seismic design, and a bridge easier to move. Using a single span also created a very flexible structure during picking and transporting. The deck steel was increased to handle the stresses during the move, and the end diaphragm was designed for maximum tolerances during placement.

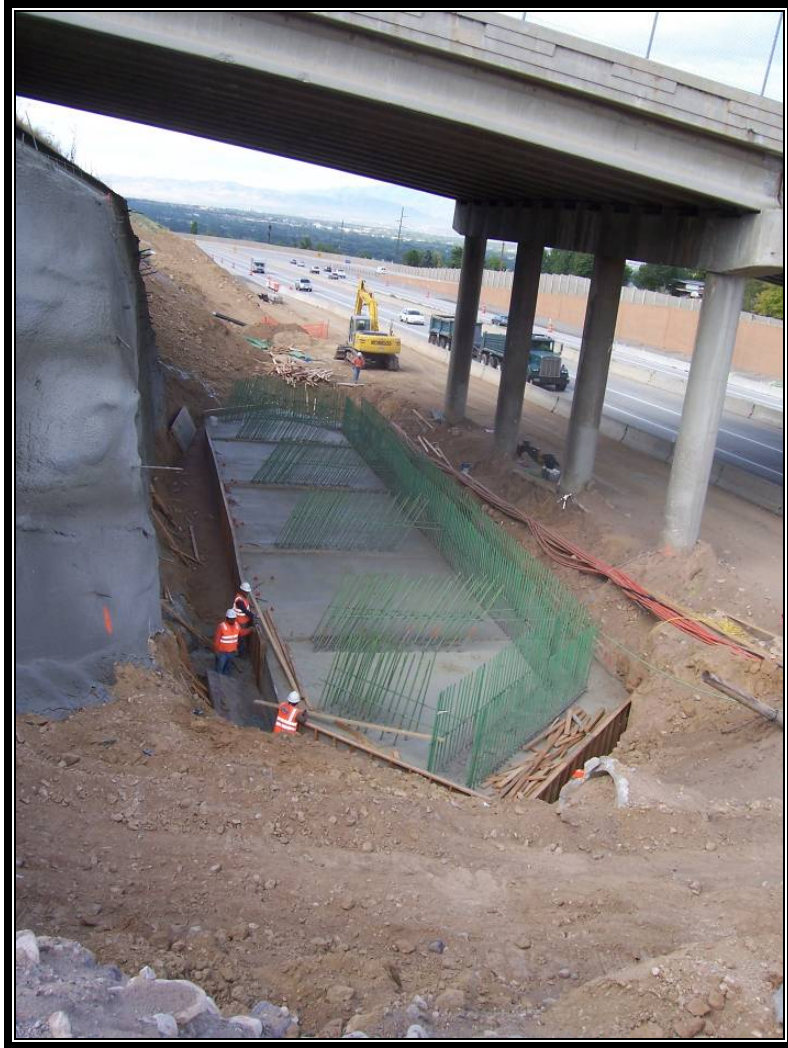
Figure 6. Abutment #2 Foundation

The abutment was designed to accommodate the minimal work area under the existing bridge. A spread footing was used to avoid the restrictive and costly use of driving piles. The vertical cuts were secured with soil nail walls to support the existing bridge. Abutment #2 required a 40-foot high wall with a 12% back slope and counter forts.

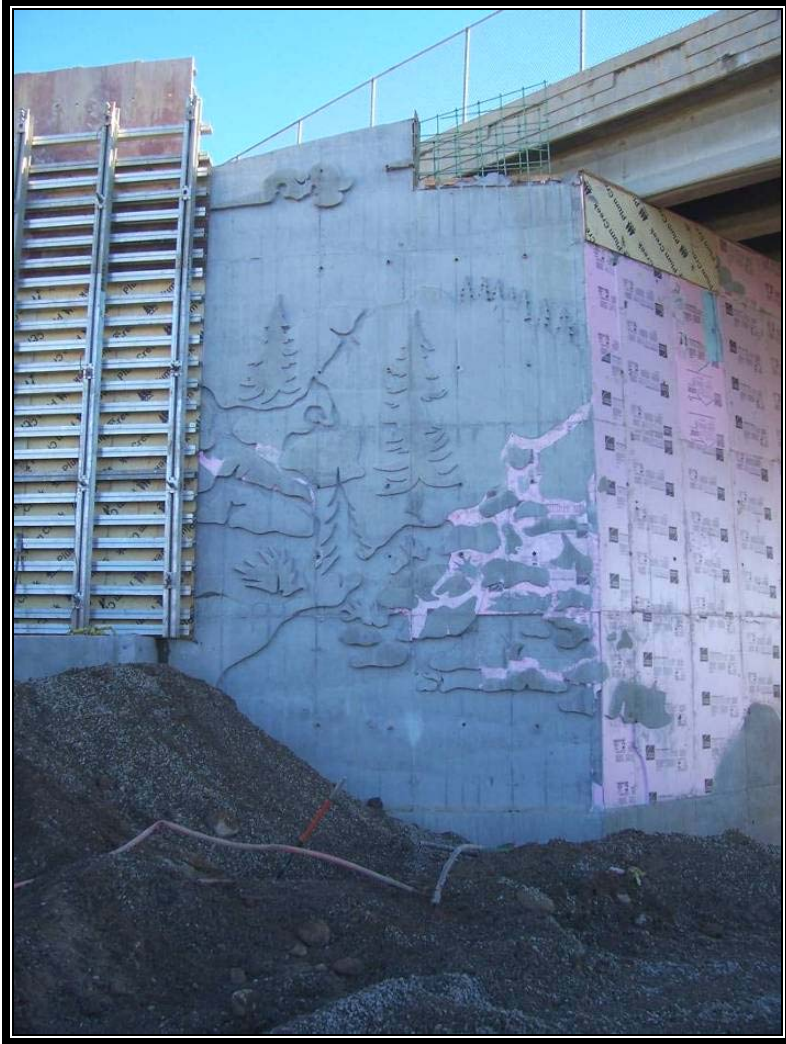
Figure 7. Abutment #2 Construction

Maintaining continuous traffic on 4500 South and on I-215 created a complicated substructure construction. Extensive height and width restrictions existed. Holes were created in the existing deck to pour the new foundation walls. The new girder seats actually touched the bottom of the existing girders.

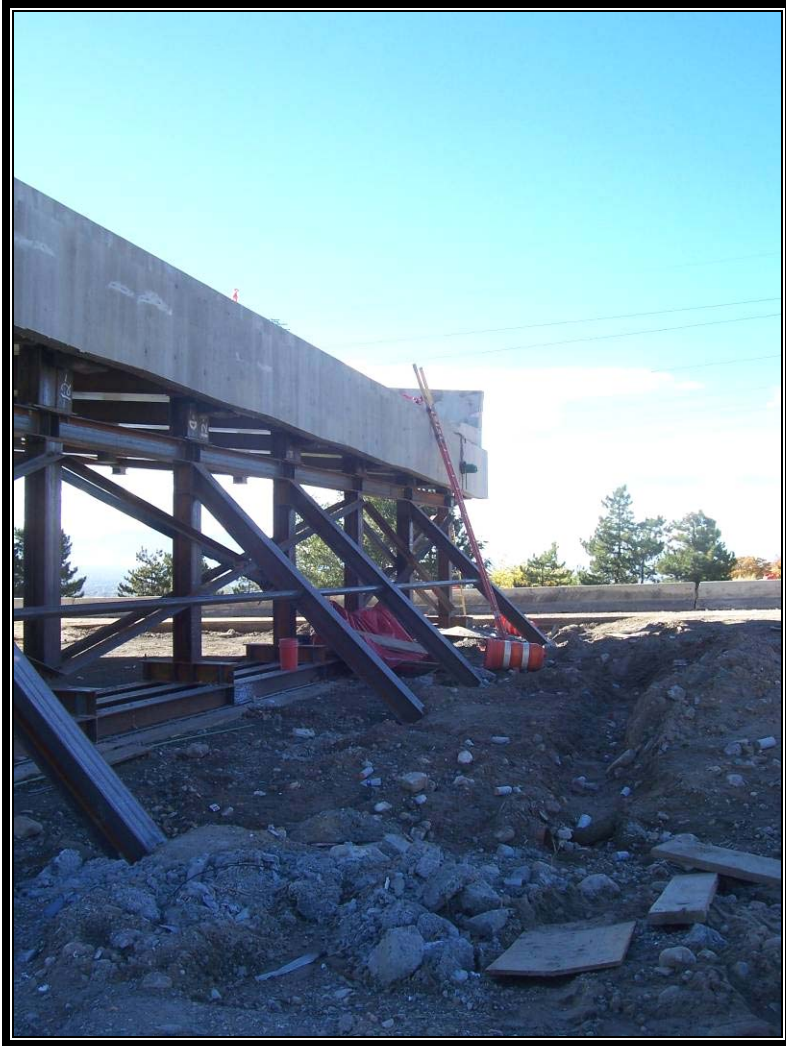
Figure 9. Temporary Abutment

The design of the temporary construction elements needed to be quick and cost-effective. The designer worked closely with contractor on the materials readily available to determine the most efficient design for temporary works.

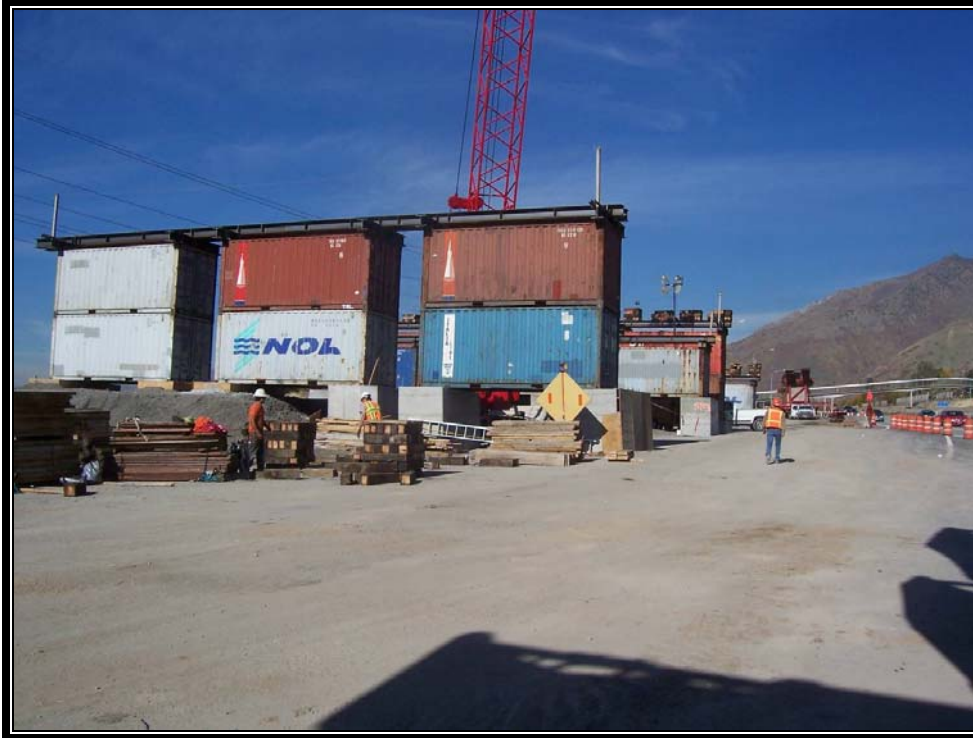
Figure 11. Temporary Demolition Site

Rail shipping containers were used as supports for the existing bridge at the demolition site, creating a very cost-effective solution. A portion of the existing bridge from the joint to the lifting location was demolished prior to moving the existing bridge due to the unknown condition of the deck.
